ANTIETAM DAM

INVENTORY NUMBER NDS PA-332

PHASE I INSPECTION REPORT

SEPTEMBER 1978

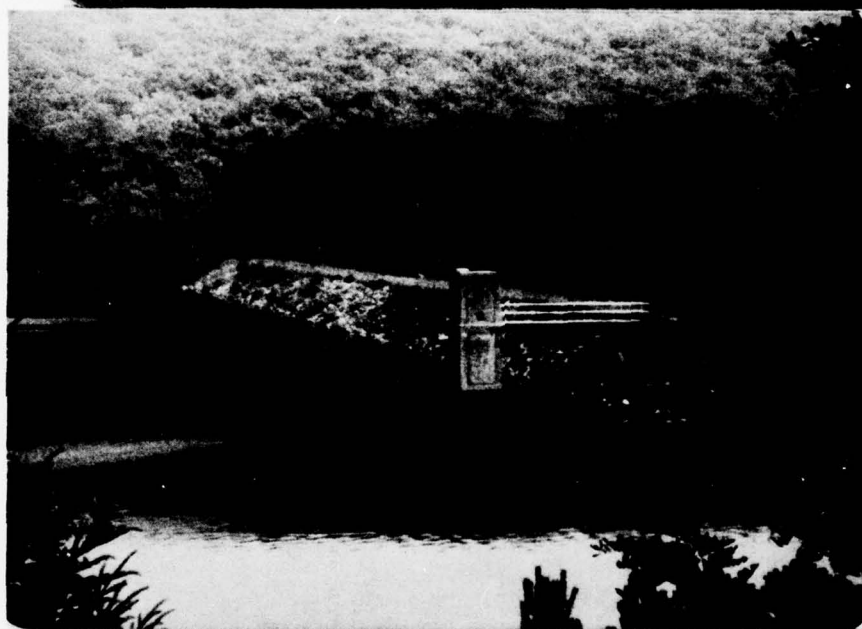
The intake tower is a concrete structure which houses three valves (two 10-inch and one 14-inch) at different elevations. The structure and its access bridge from the embankment are in good condition. Refer to Appendix D, Plate III. The gates in the tower were

Upstream Slope
& Intake Tower

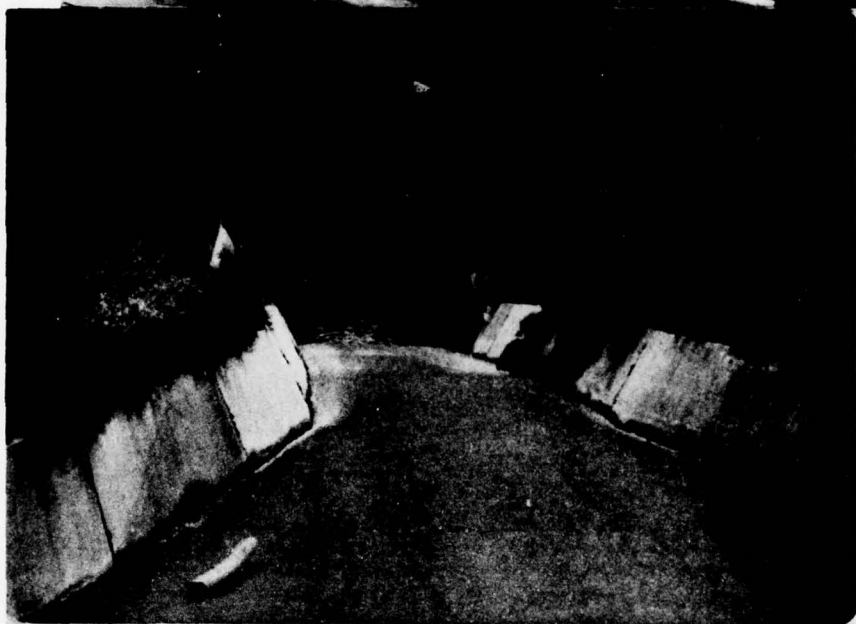
The spillway, which is an uncontrolled concrete ogee section shows some slight weathering on the surface as a result of the flow of water. The abutments appear to be in good condition although there are some very fine cracks in the walls with calcite stains. The concrete slabs in the spillway outlet channel and the walls along this descending chute are in good condition. Refer to Appendix D, Plate IV. The foot-bridge across the spillway is also in good condition as is the stilling basin.

Spillway Chute

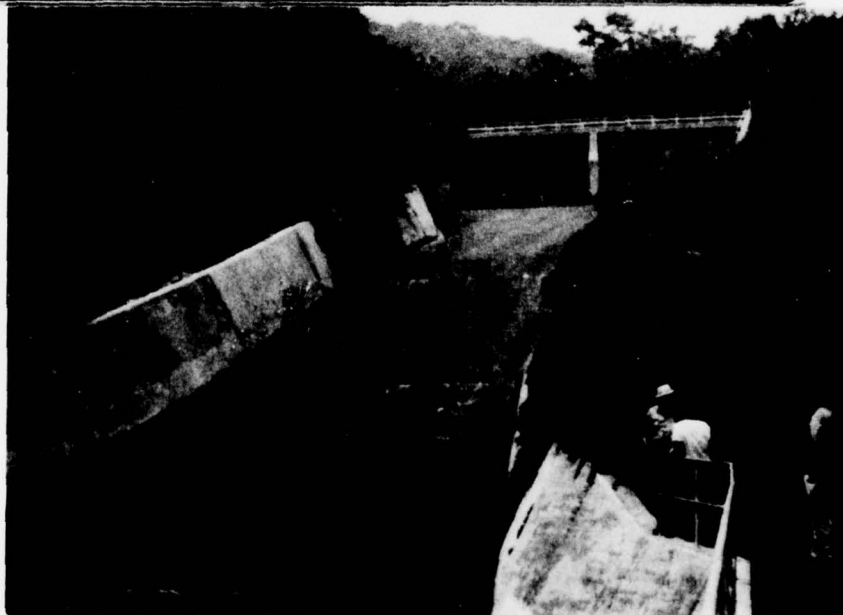
Spillway Chute
And Bridge
